WILDFIRE RISK MITIGATION

FOR ELECTRIC UTILITIES

A compendium of articles from
T&D World contributors

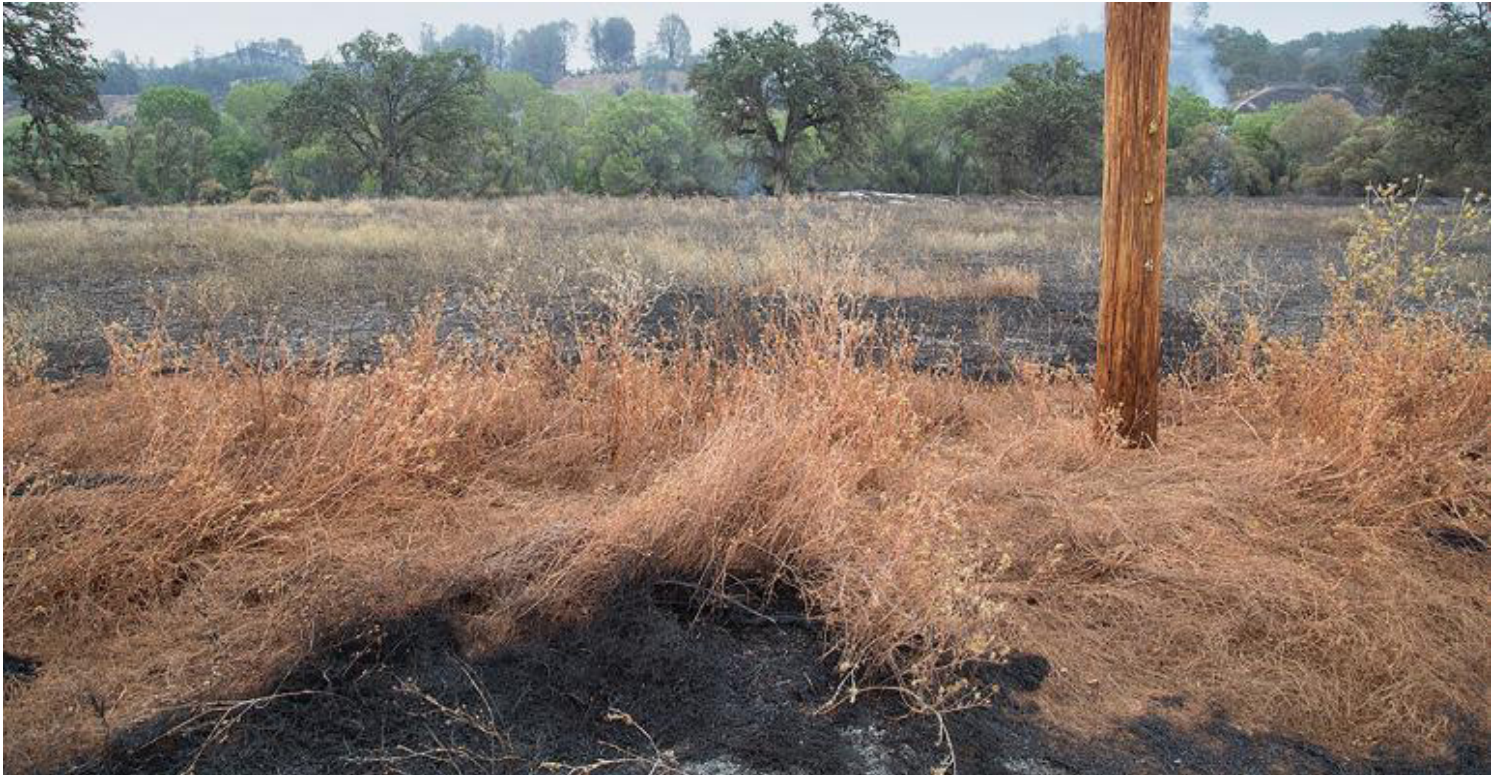
Pole and surrounding vegetation pretreated with LTR well in advance of a fire. There was no damage.

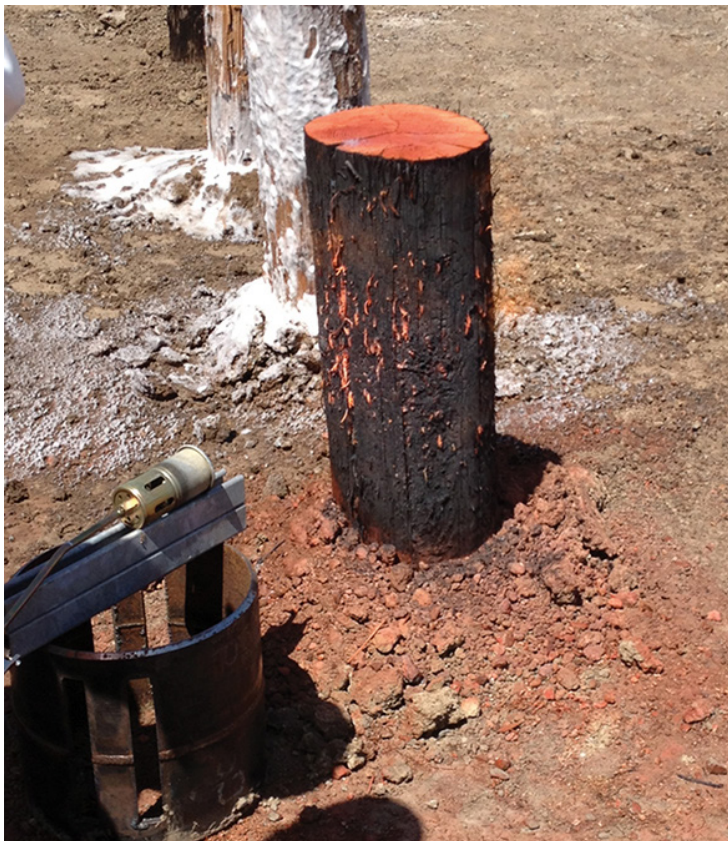
Pole pretreated with long-term retardants exposed to a flame from a propane burner at more than 2000°F (1093°C) did not ignite or show any damage.

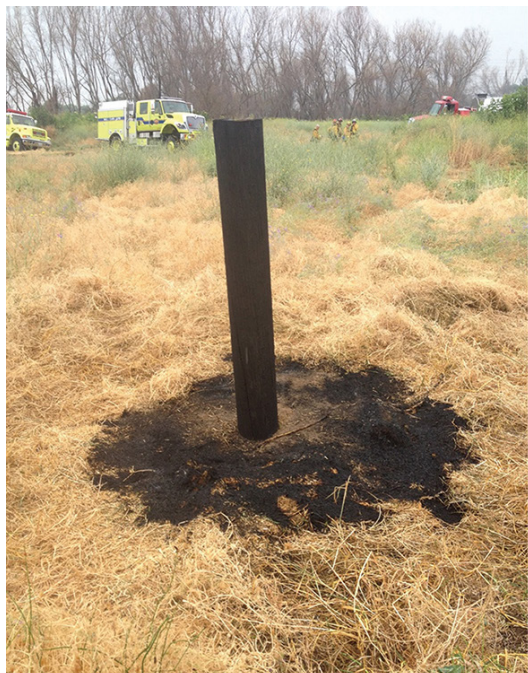
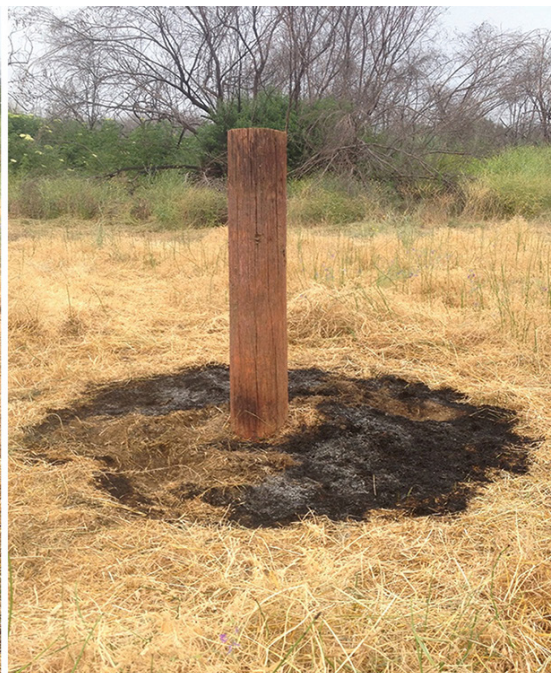
Results of a controlled live fire where dry vegetation stacked around the pole burned and ignited an untreated pole. The pole had to be extinguished (left). Results of a controlled live fire where dry vegetation stacked around the pole burned but did not ignite or damage the pole pretreated with long-term retardants (right).

Testing and evaluating the use of fire retardants, by simulating conditions that would typically be encountered during a wildfire, can be conducted on wood utility poles to compare the effectiveness of various fire chemical agents. A series of tests were conducted by Pacific Gas and Electric Co. (PG&E) in which utility poles were treated and exposed to a standardized flame for a specified period. Based on the experience of staff at PG&E and testing conducted by the author, LTR products were determined to provide the best results in this evaluation.

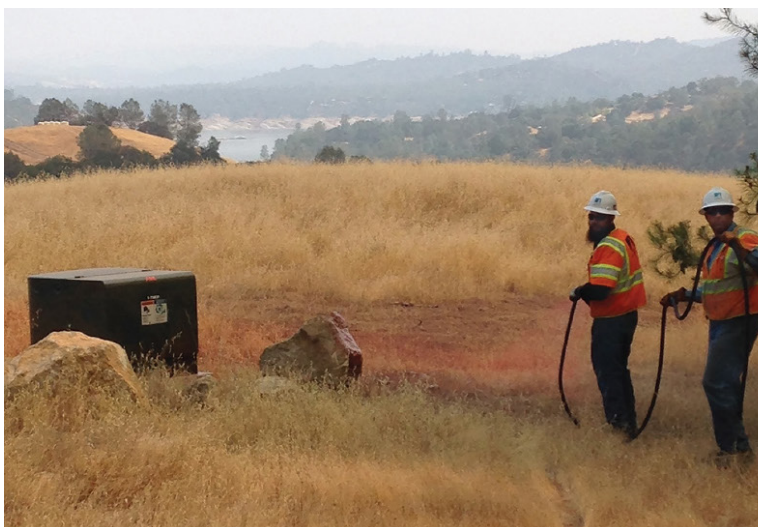
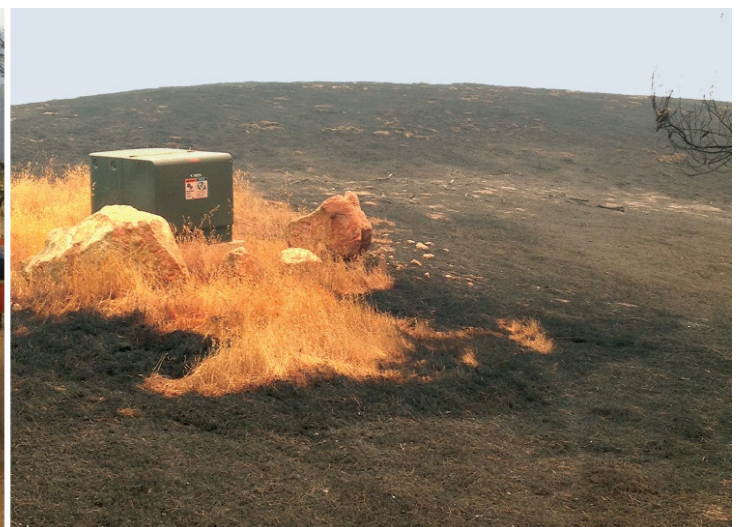
Before and after scene from 2016 fire in San Luis Obispo County. Area around pad-mounted transformer is pretreated with long-term retardant a day prior to fire burning through the area. After scene shows the effectiveness of the treatment - no damage.

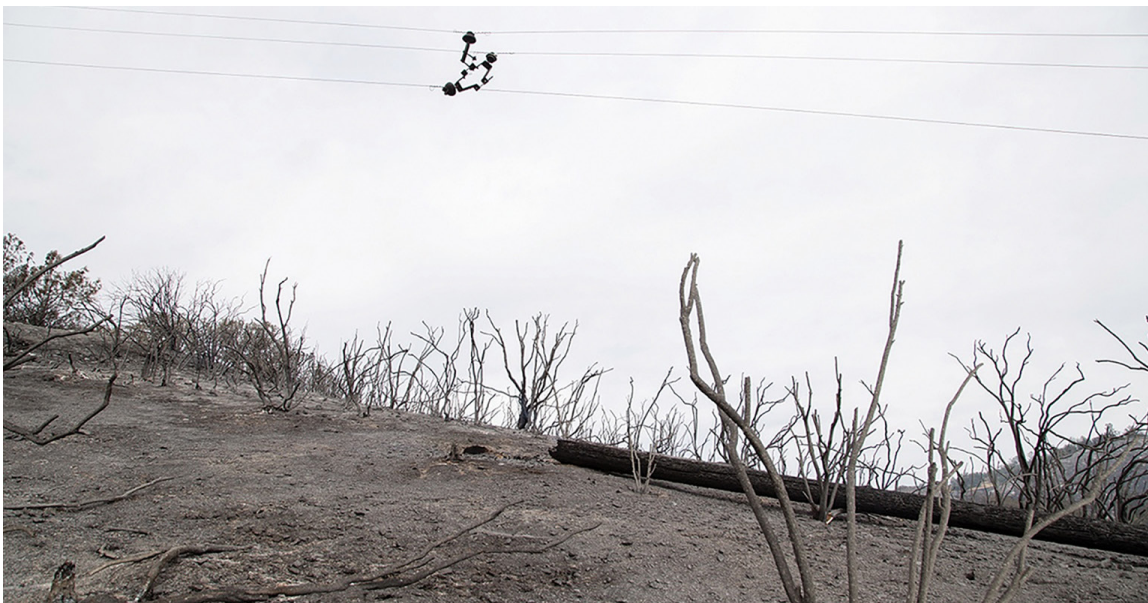
The insulators on these wires mark where an untreated pole was before the fire destroyed it.

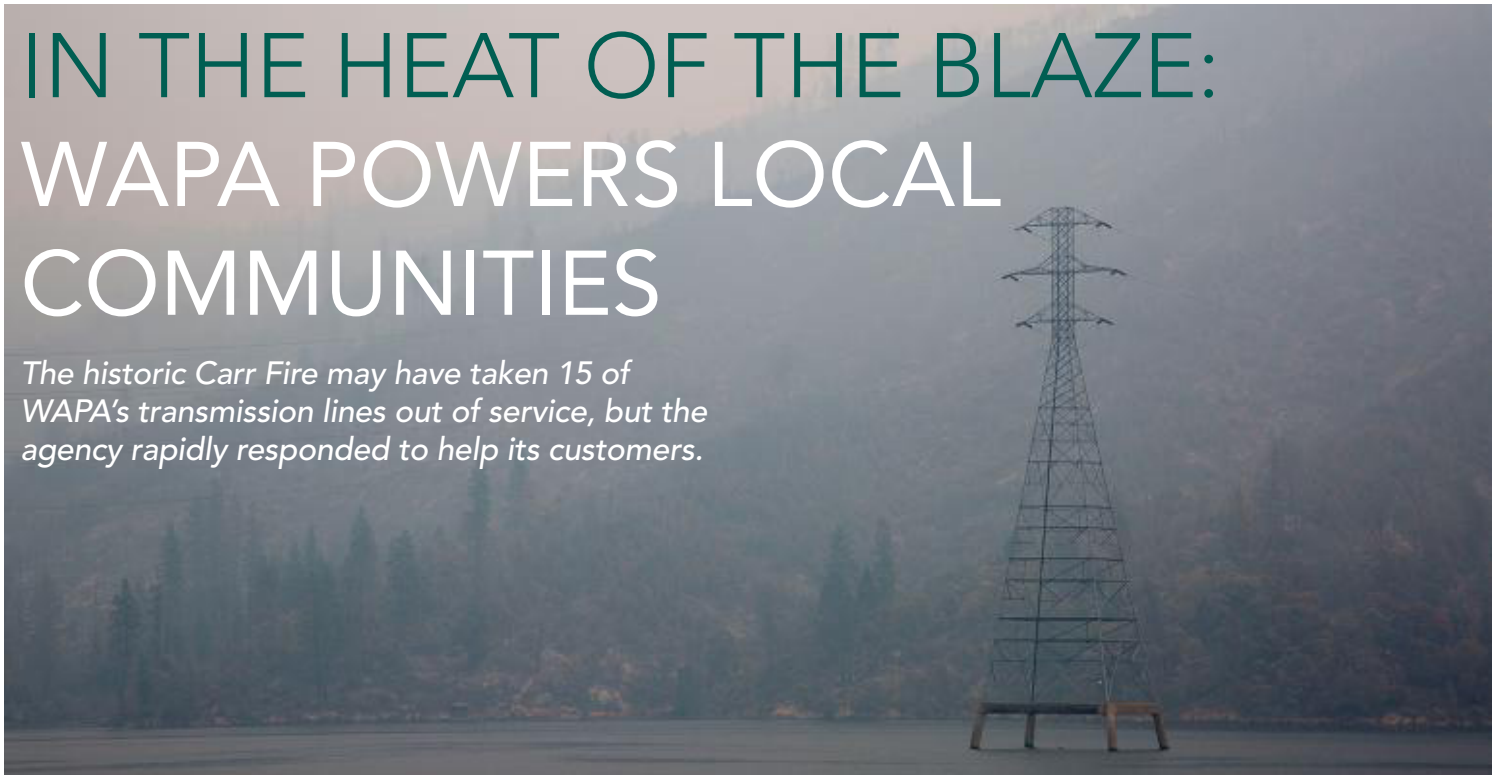
A transmission line stands on the water in the smoke.

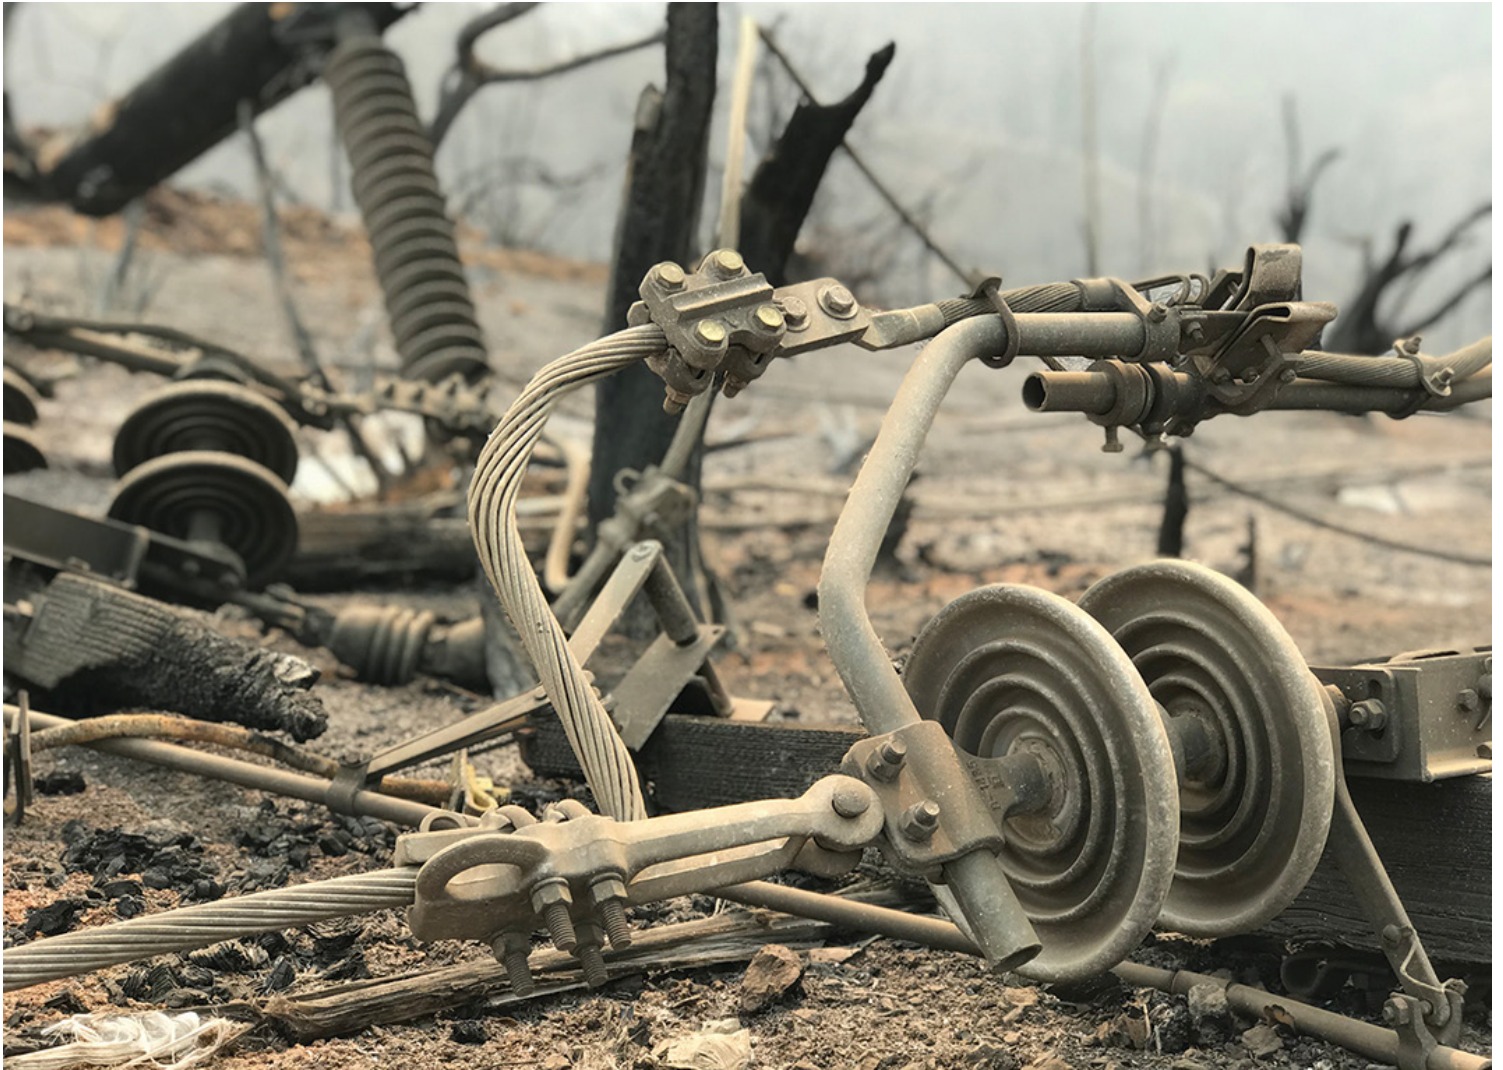
A destroyed tower outside Redding, California.

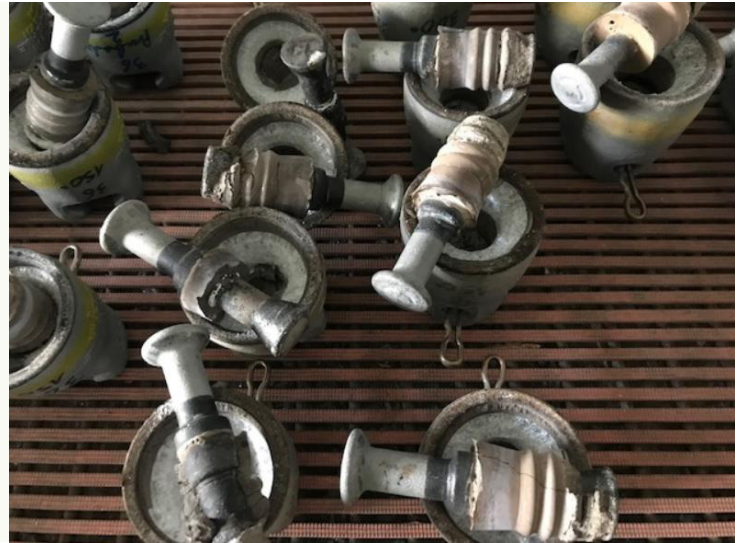
Wildfires can have multiple causes. Overhead lines often just happen to be on the path of a fire, and in this case it is critical to understand what may happen to the line and its components. Besides the risk of having phase ground faults resulting from intense arcing activity in the smoke and heat cloud, resilience is paramount and the amount of damage to lines is a direct consequence of line designs. Distribution overhead lines are obviously much closer to fires than transmission lines and therefore suffer much more of heat damage. Wood poles are clearly identified as a weak link under such circumstances but insulators can also become critical. Even for transmission lines the heat impact can be substantial but not necessarily immediately visible in the short term. Some specific physical characteristics of overhead line insulators need to be clearly identified and taken into consideration either to evaluate the risk of having a line drop during the fire or years later as a result of a weakening of the insulators which survived the fire in the first place.

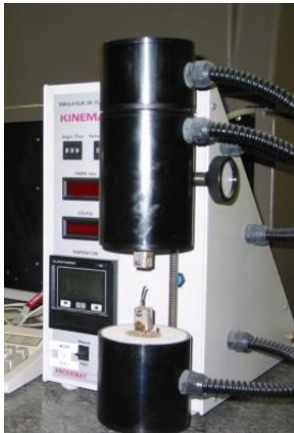
Figure 2: Torsional strength test showing the loss of resilience at the Tg set point

a. Polymer insulators: The combination of the crimping compression of the end fitting over the fiberglass rod itself sensitive to heat (see figure 2) can be feared as a weak point under heat conditions. In order to establish this property tests were performed with various composite insulators (mostly distribution dead ends). Samples were introduced in an oven for 3 hours and pull tested while still hot until failure occurs. Figure 10 shows the normalized results with a reference at 100% corresponding to their ratings. It appears clearly that the strength goes rapidly below the everyday load design of the line.

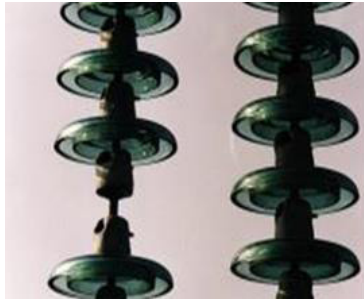
Figure 9: Typical aspect of a "stub"

homogeneous as seen in figure 6. The glass is toughened for strength purposes and the prestresses built in the bulk thickness of the dielectric are a balance of compressive and extension forces (figure 8). The mechanical shield represented by this toughening operation makes glass immune to any crack propagation or puncture. A toughened glass insulator will either be intact or shatters if any excessive adverse stress is applied. In this case the glass insulator becomes a so called “stub” (figure 9) which electro me-

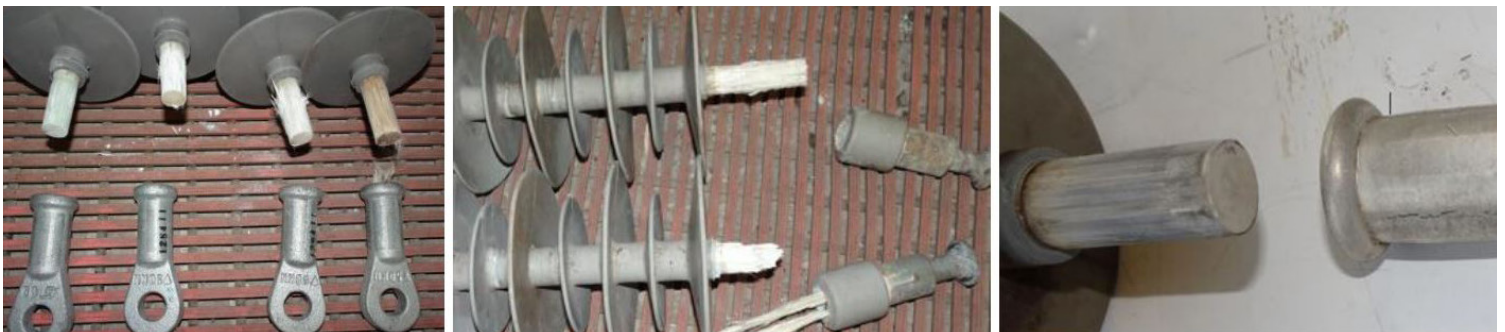
Figure 12: Typical aspect of the tested units after the mechanical pull test

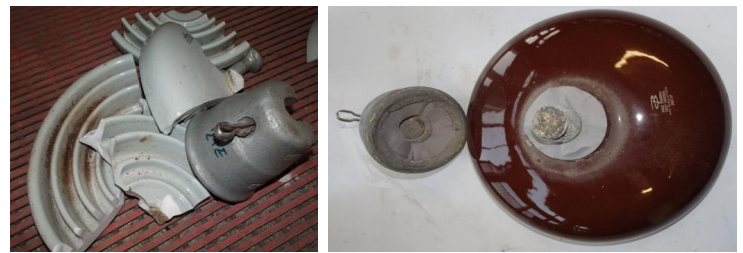
Figure 14: Overall aspect of the insulators after the test

b. Porcelain insulators underwent a similar test with various insulators placed in a furnace for 3h before being pull tested. Given the risk for porcelain to puncture the relevant test in this case is the ANSI M&E test. A number of units failed with cracks either visible or not. As expected, the difference in expansion between components favors this type of failure. However, and while most units survived their mechanical stress with no separation below the rating, most failed electrically from internal punctures not visible from the outside. This demonstrate that once porcelain insulators have been directly or not in contact with high heat there is a major risk for having hidden defective units on a power line. Figure 13 shows the M&E test results and figure 14 the typical physical aspects of the units after test.

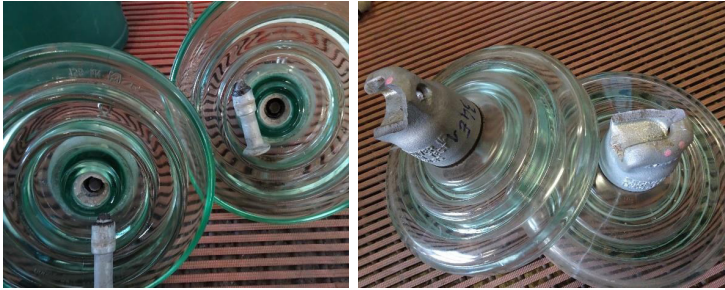
Figure 17: Typical aspect of the glass units after the test

In a few cases the glass shattered before the mechanical separation, but in all the other cases the failure mode was a breakage of one of the fitting, usually the pin as shown in figure 17. It is also interesting to note that, while all the results seem very stable the lowest performer was assembled with Portland cement. Without enough elements to come to any conclusion on the influence of cement, it can be interesting to remember that Alumina cement is a better thermal refractory than Portland.

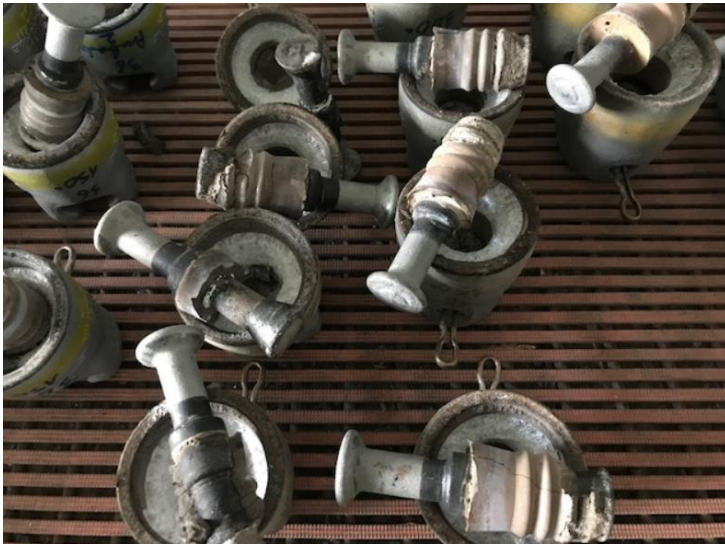
Figure 19: Overall aspect of the stubs after the mechanical test under heat conditions

the cement with the pin from the inside of the head of the insulator as shown in figure 19. All the values remain above 65% of their initial rating, which is the requirement in ANSI for new insulators tested for their residual strength.

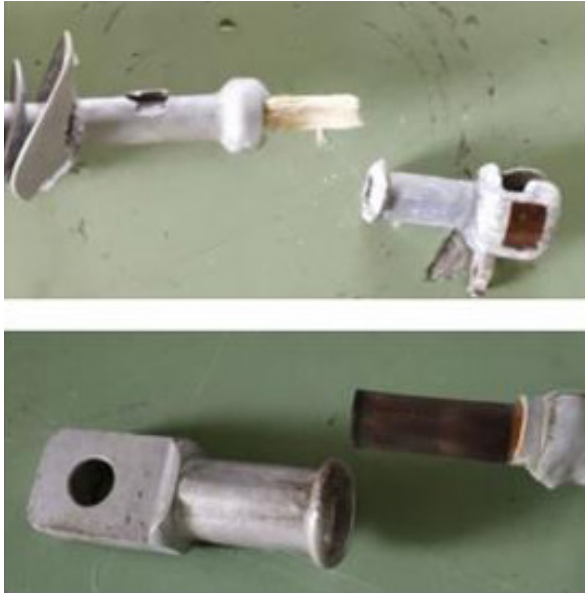
Figure 20: Fitting pull out after the insulators were cooled down after a heat cycle at 300°C and comparison with results on glass stubs tested in the same conditions

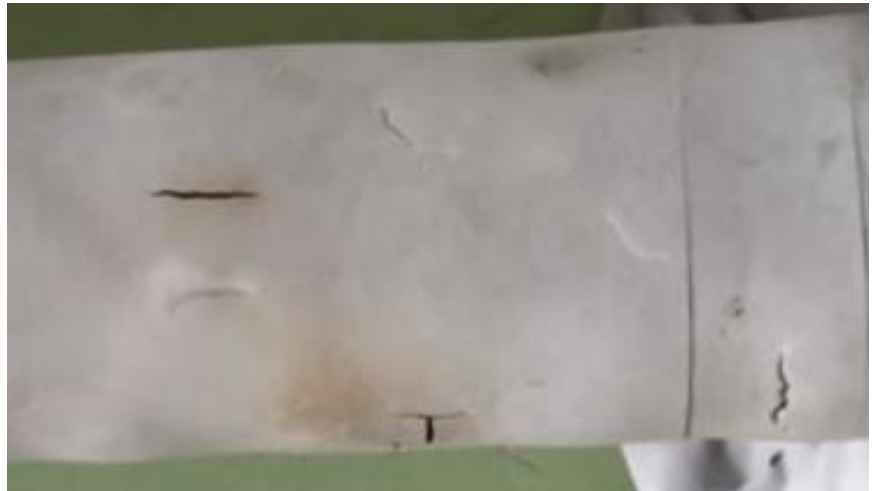
Figure 21: Cracks in silicone housing left after being subjected to heat for a few hours

(brittle fracture, decay fracture...). It is important also to consider the existence of sulfuric acid and other fire related acids which will destroy progressively the core of the insulator. In most cases these degradations are not easy to spot visually as shown in several cases presented in figure 21.

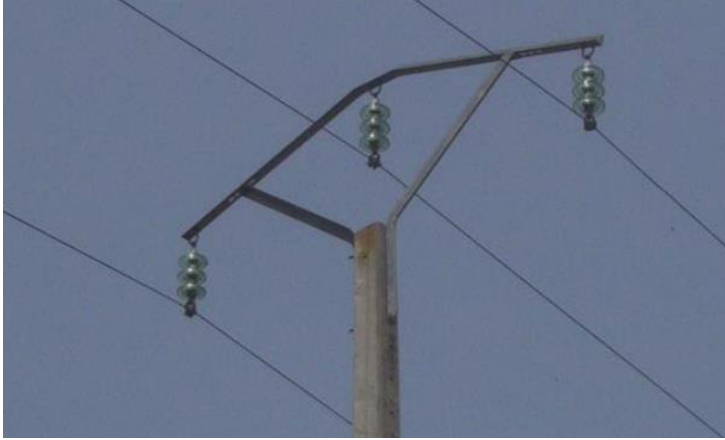
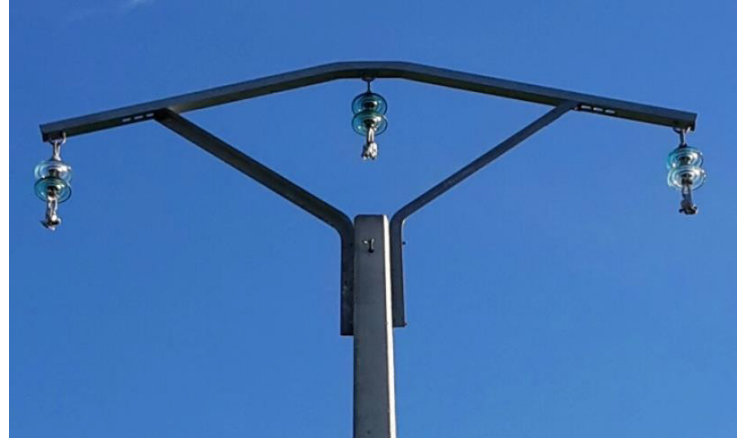
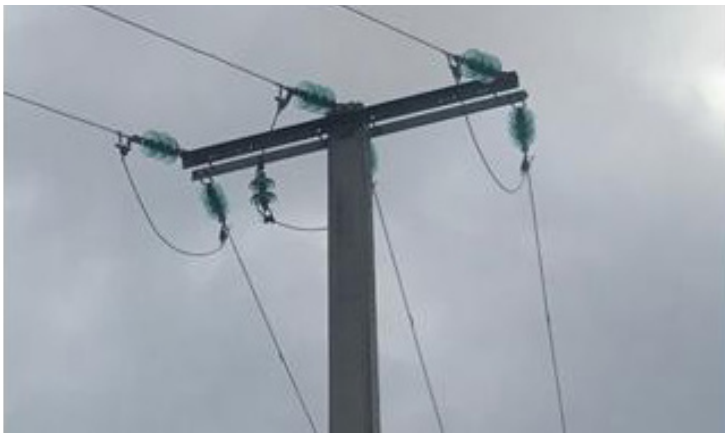
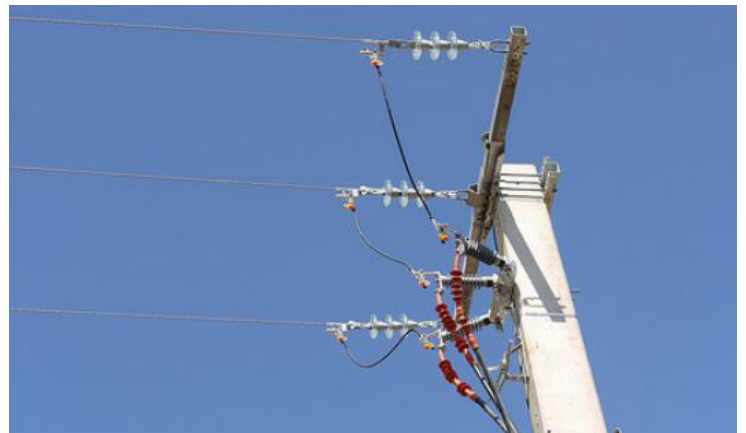
Figure 22: examples of resilient distribution lines using concrete poles and toughened glass insulators in suspension and tension.

It appears also that a tensile load is easier to secure consistently than bending loads. Therefore a line design where deadends are strictly made of glass with tangent structures made of concrete with suspension glass cap and pins would offer the best resilience. The grid hardening would result from insulators immune to heat and a mechanical structure where heavy duty strings working systematically in tension with ratings which could go up to 20kips or 30 kips or more are being used. Figure 22 gives examples of such systems using glass insulators for their strong resilience to adverse environments such as those encountered in fire driven environments or areas where conductors are not allowed to touch ground under any circumstances.
